GENERAL ANNOUNCEMENT PROGRESS AT GLENFINE – MIN 5492

Mount Rommel Mining Ltd

MIN 5492 - Glenfine

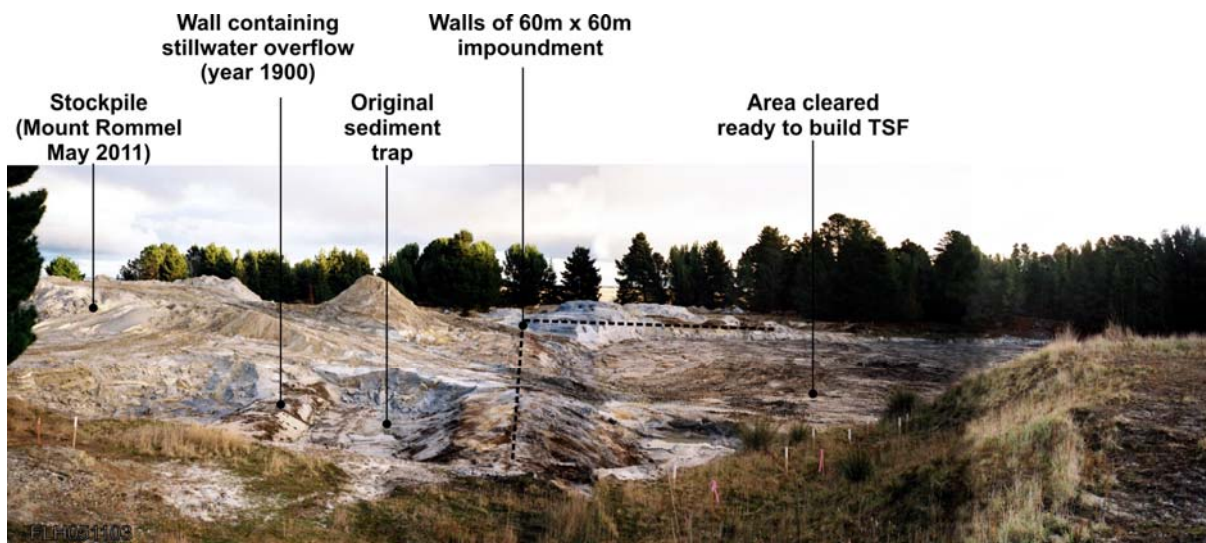
4 p.m. 26 May 2011

Excavations underway at Glenfine reveal the elevated gold values to be where portions of these older tailings were impounded behind substantial clay walls of height about 1.5m. Created before year 1900, the primary impoundment forms a rectangle, wall lengths 60 metres, complete with overflow and sediments trap – see photos and plan below.

Work on site reveals three similar clay wall impoundments. It is the footprints of these impoundments which define the places carrying elements considered to be “contaminants” today.

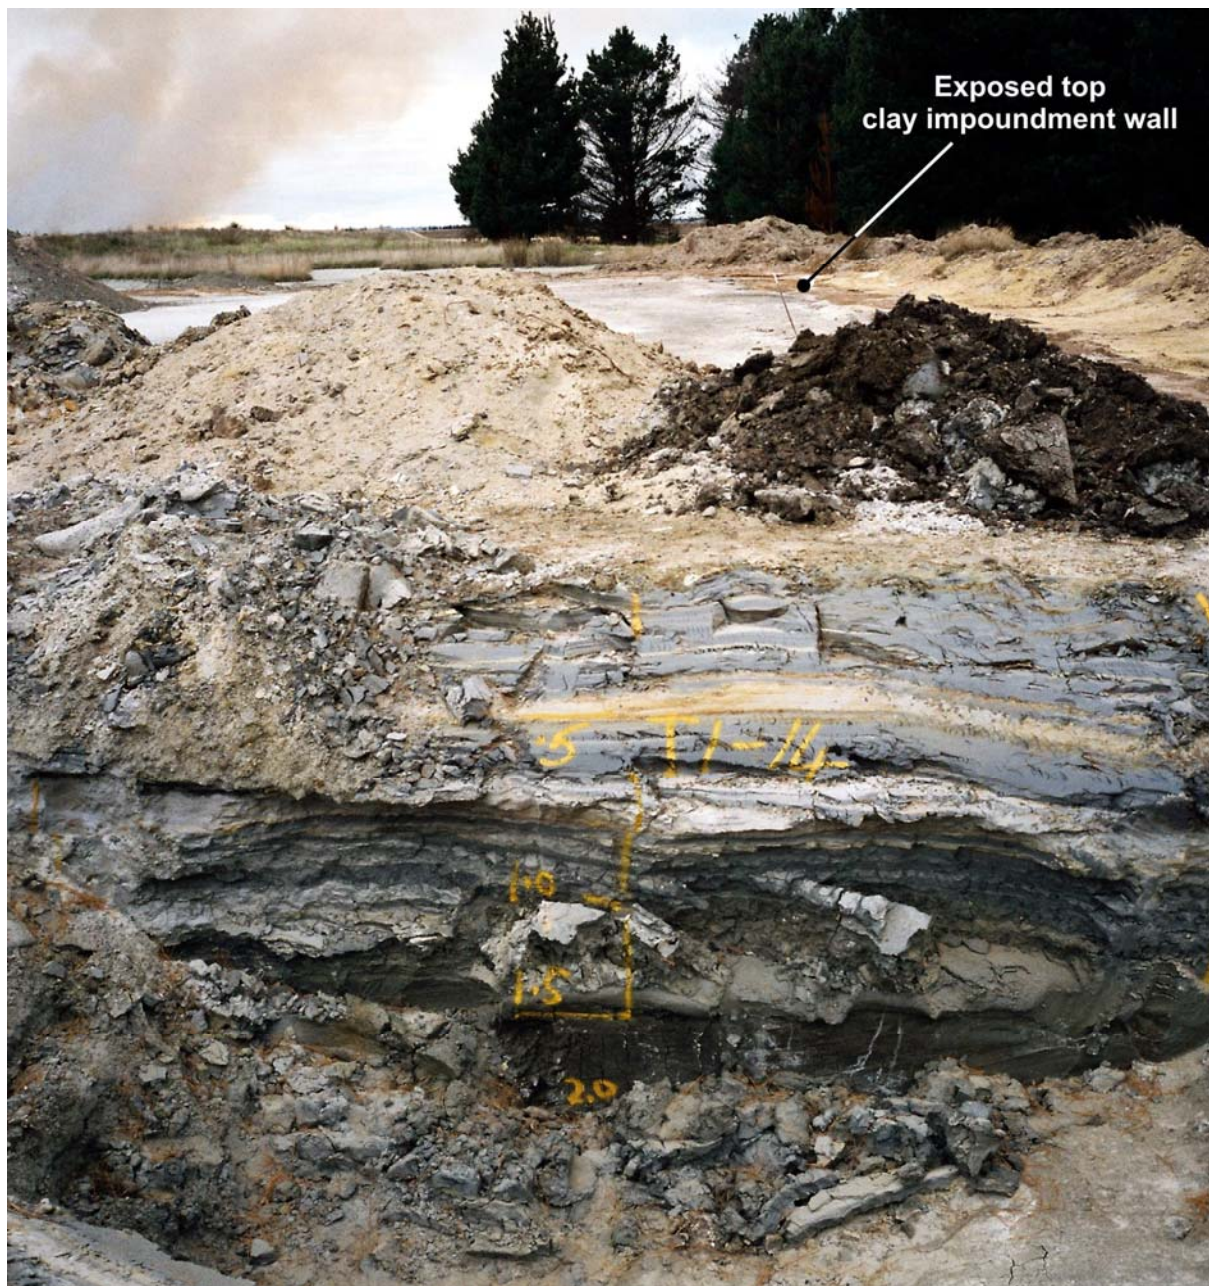
Trench 1, at 14m	Depth	Au (ppm)	As (ppm)	S%
Basalt clay in floor	1.5 – 2.0m	-	37	0.09
Grey slum with some sand	1.0 – 1.5m	3.35	1874	0.51
Grey slum with cream sand	0.5 – 1.0m	3.38	2357	0.25
Slum and sand	0 – 0.5m	5.64	2327	0.32
Overlying gravels at surface – not represented

A photograph of Trench 1, at 14m, gives a visual illustration of these old tailings, undisturbed for so many years.

The arsenic levels in these samples are typical of certain types of tailings at this site. As the arsenic levels exceed by 6 or 7 times the regulatory limit level for arsenic as a “contaminant”, and the site extent is confined, there is no capacity to dilute the waste so as to satisfy regulatory limits – see other comment below.

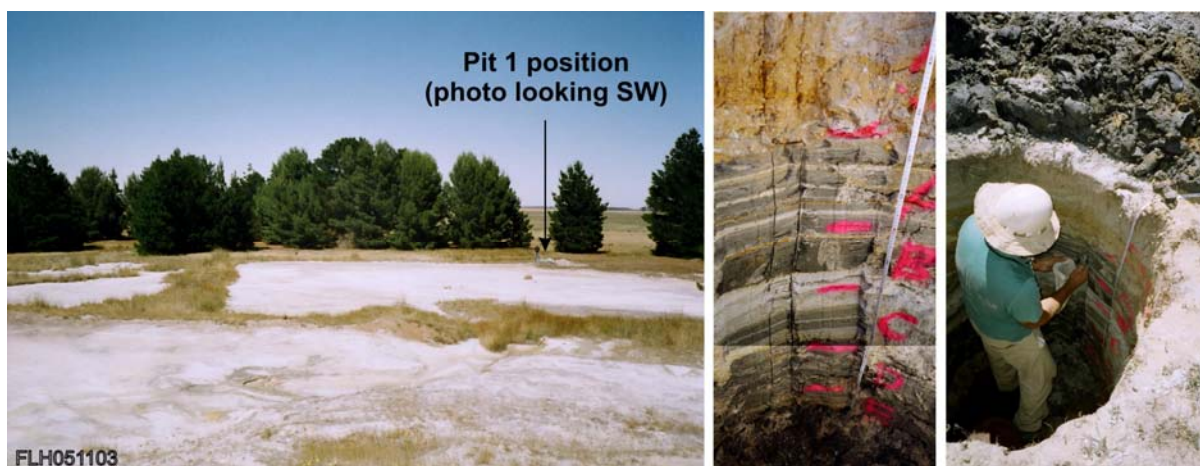
The excavation of Trench 1 confirmed the character of materials (and gold content) as first seen in Pit 1, as illustrated in the following three pictures released on the Company website 7 January 2009.

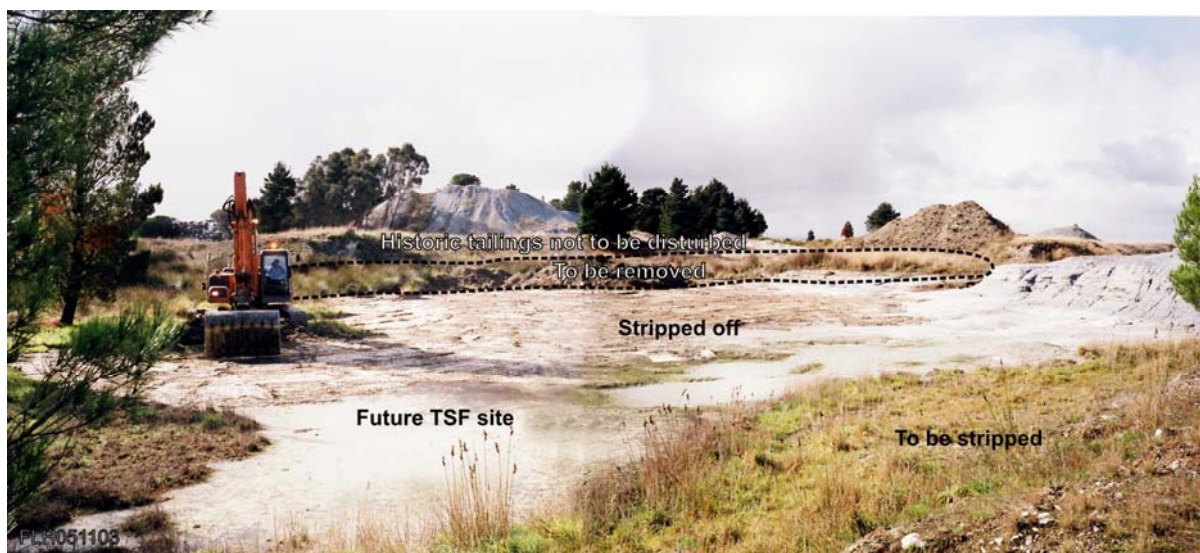
Surface vegetation has been stripped off and trucked to stockpile (it contains sands) so opening up the area chosen by Mount Rommel and subsequently approved as the area for the specified Tailings Storage Facility (TSF).

Above photo looks north-east across the space intended for the construction of the TSF – stage of stripping off pre-existing vegetation.

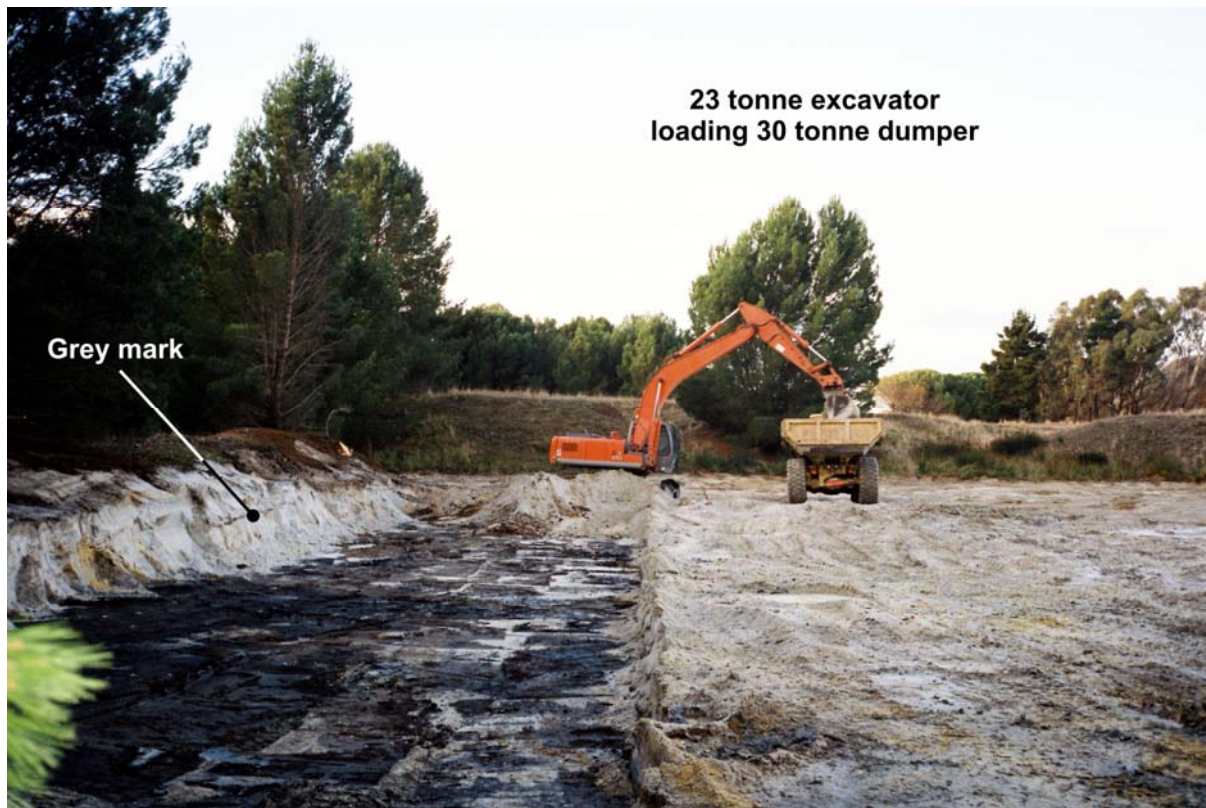
4 p.m. 23 May 2011

Stripping off the sands originally deposited from the “permanent” battery at No.2 shaft, the Glenfine South mine, commencing 10 December 1900.

The white sand in the photograph is the battery product from crushing quartz, stoped above the 253 ft level in the No.2 Shaft. The thin layer of grey sand (see

photo) indicates beginnings of change in rock type passing through the original No.2 battery

*First report 17 December 1900 –
910 tons treated for 931 oz 15 dwts recovered.*

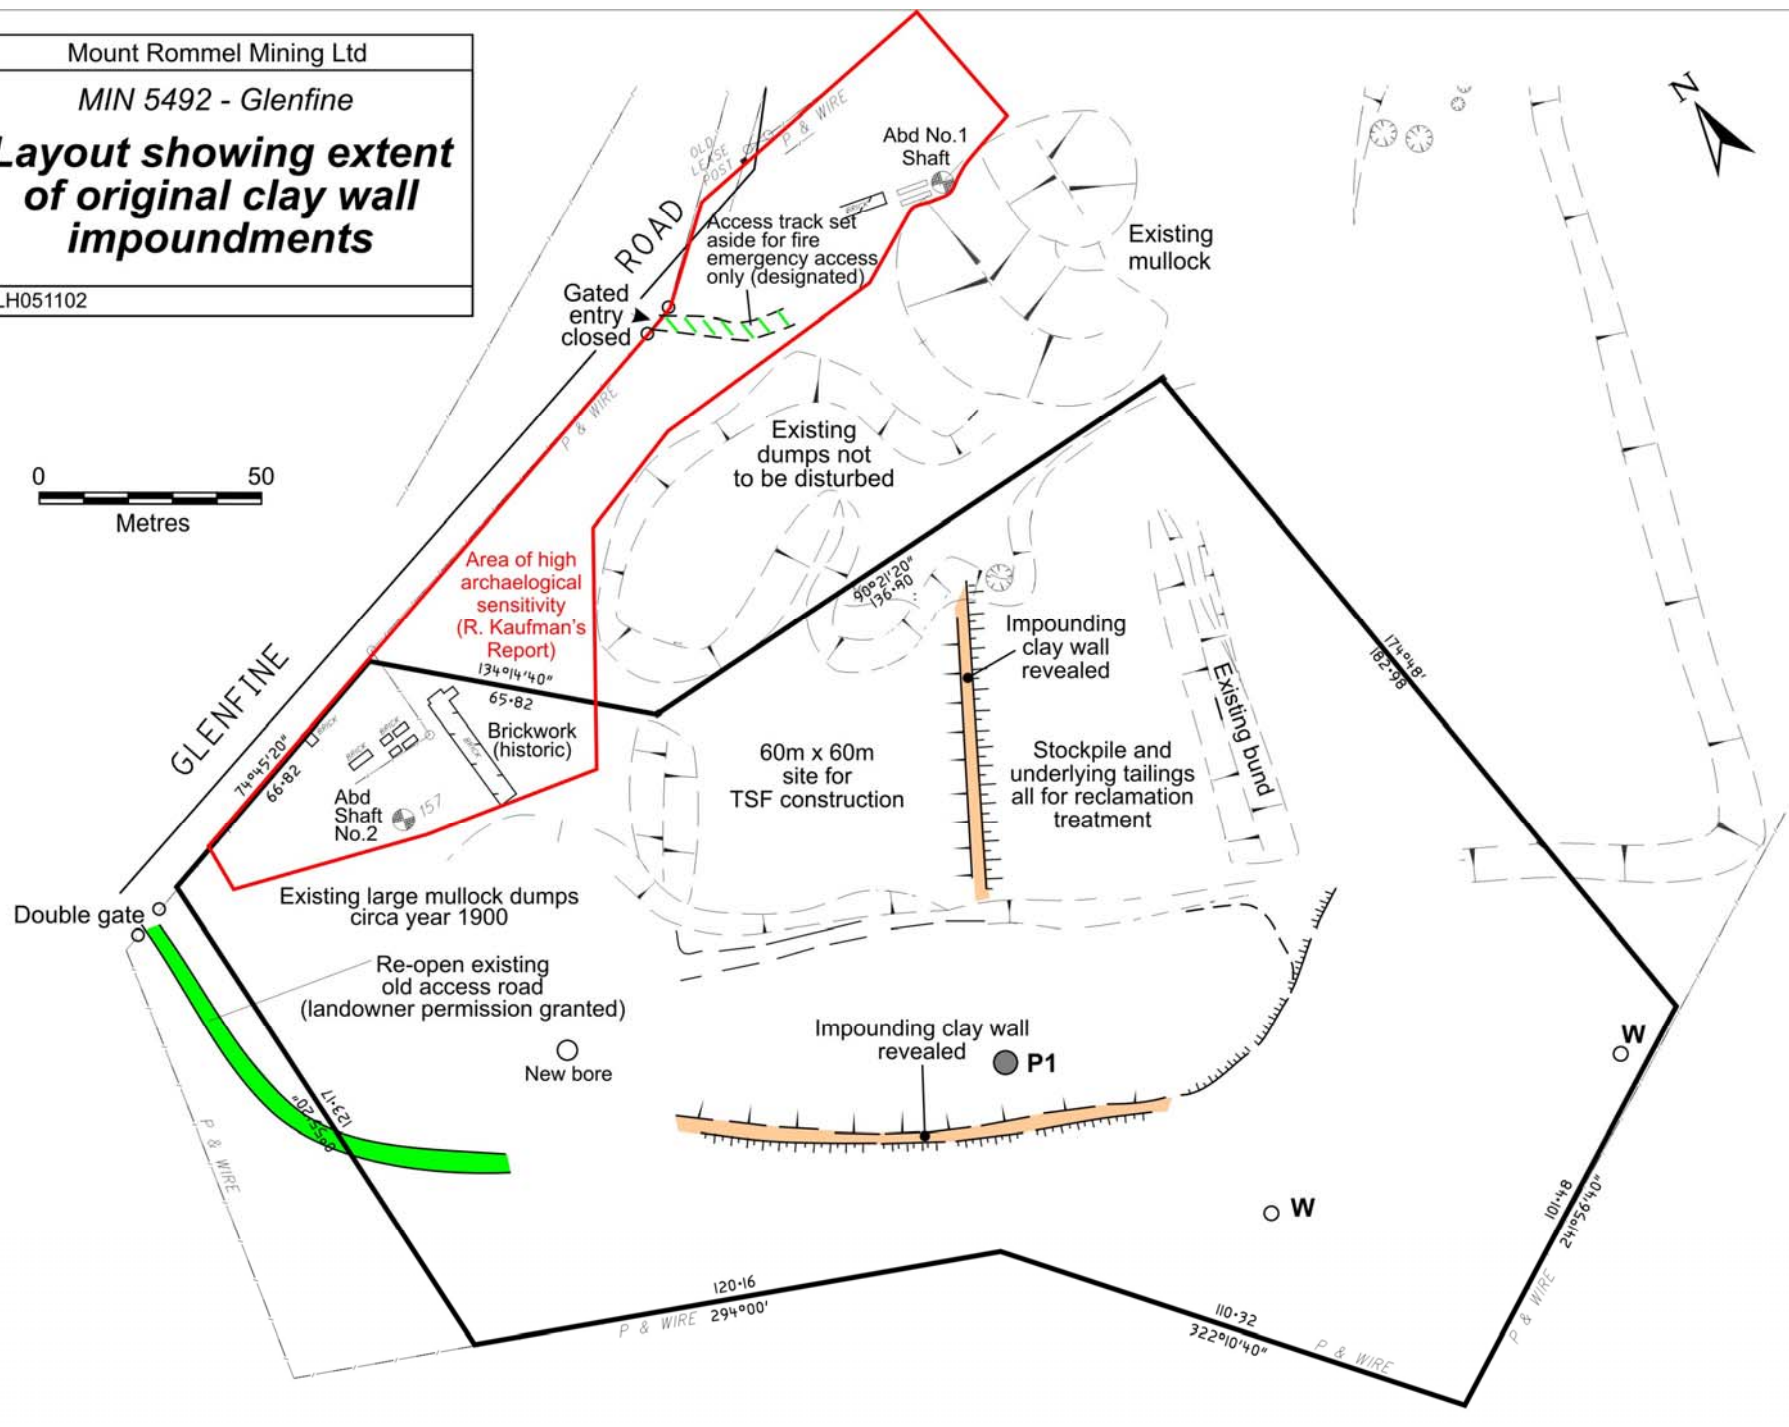
**Layout showing extent
of original clay wall
impoundments**

The area approved for the TSF has been readied for placement of the seepage cut-off trench, construction to commence 31 May 2011. This compacted clay “structure” fits entirely within the bounds of the original clay impoundment area shown on the plan below – thus site remediation and respect for site history together become part of the gold recovery operations of 2011.
