6 June 2011

## GENERAL ANNOUNCEMENT - PROGRESS AT GLENFINE MIN 5492

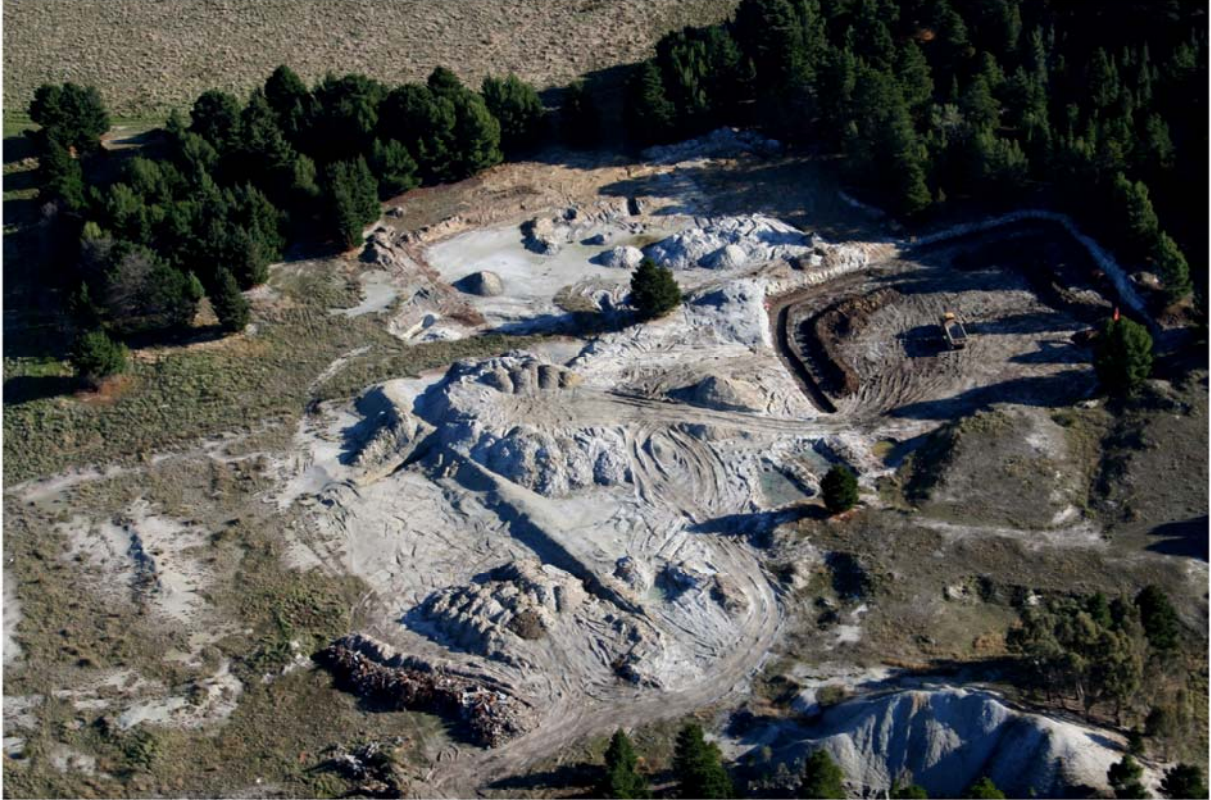
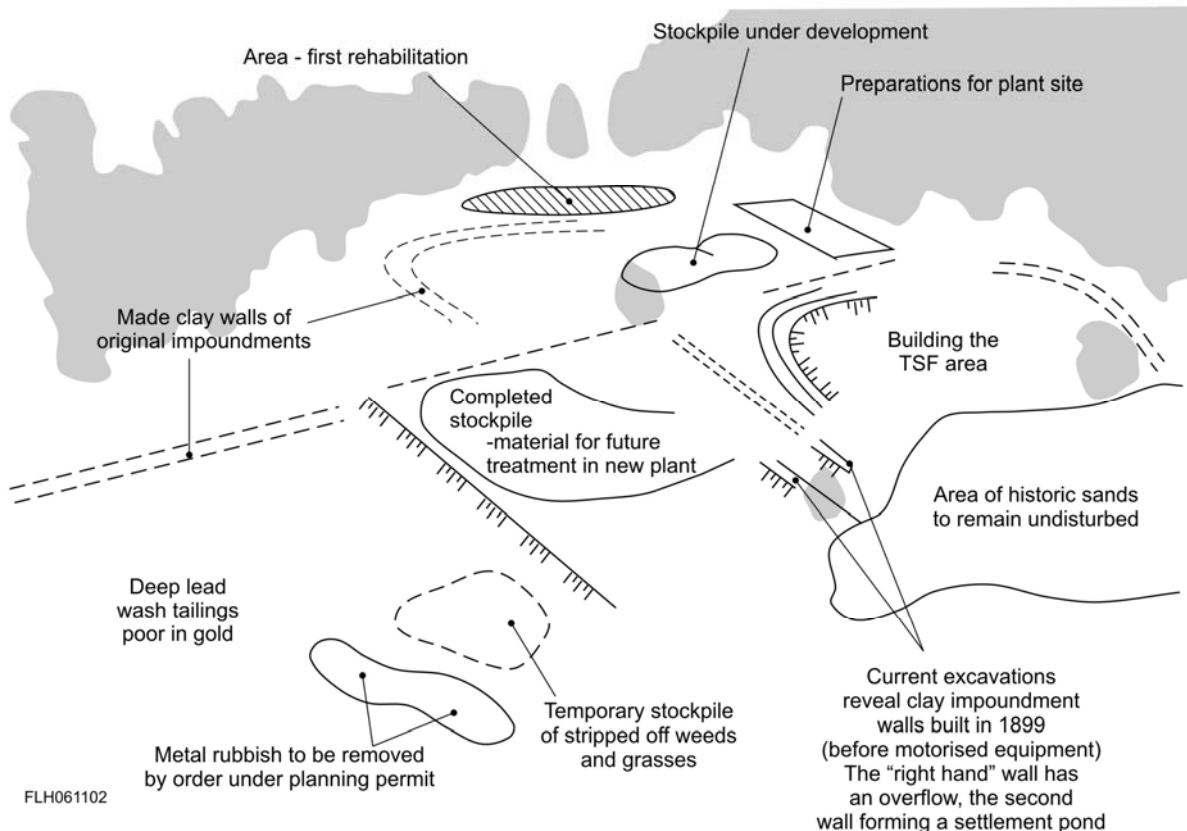
*This photograph taken from above in the early afternoon of 31 May 2011 illustrates how the site is developing rapidly in accordance with the approvals held by the Company.*

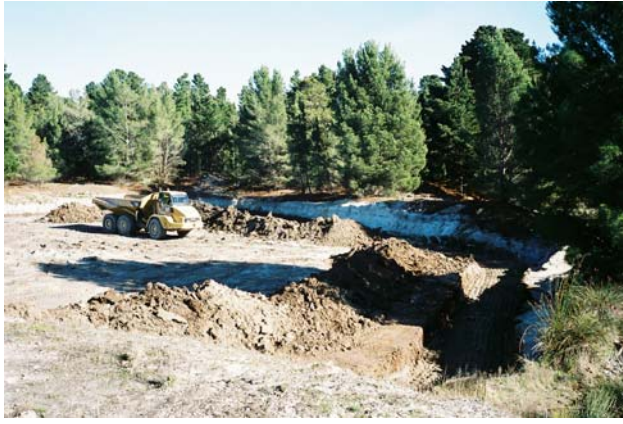
This photo shows the specified cut-off trench, depth 600mm, which provides a perimeter barrier to moisture seepage. The compaction standard for the floor and also for each 300mm compacted layer to fill this barrier trench has been set by EPA, and is required to be proven met, all under the conditions set down in the Work Plan. The evidence of proof becomes demonstrated by routine tests. Satisfactory results for layer compaction are a necessary part of the TSF building program.

As at 4<sup>th</sup> June, 2011, the backfill of this critical barrier was completed. Results of testing (on same day) are also anticipated to meet the required standards, and thereafter the "wall building" of this TSF should proceed rapidly.

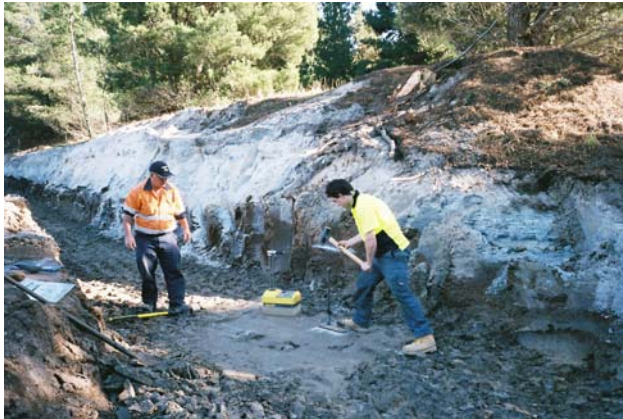
In the Ballarat district, compaction testing is carried out by A.S. James Pty. Ltd. ([www.asjames.com.au](http://www.asjames.com.au)).

This photo shows the base of the trench under test about 1.30 p.m., 1<sup>st</sup> June, 2011. In addition to field tests, a 25 kg sample is excavated out of the probed material, and tested at the laboratory in Ballarat, 52 km away. The elapsed time for results is about 20 hours. First test results were received 2<sup>nd</sup> June, 2011, confirming the basaltic clay on site and within MIN 5492 is good quality, well able to meet EPA standards for minimal permeability. The first inspection by the independent engineer who is to complete the as-executed works report to Government also took place 2<sup>nd</sup> June, 2011.

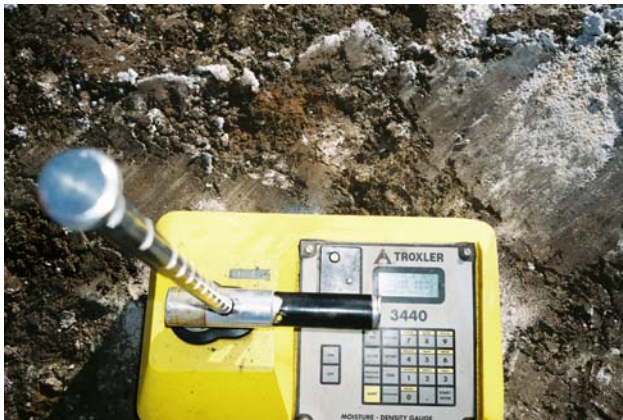
*This is the "face" of the yellow box-mounted equipment seen in the photo above. It assists in Density Determination. It is a Nuclear Density/Moisture Gauge.*

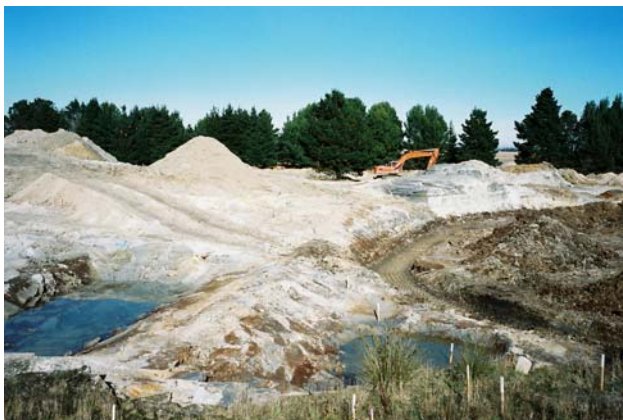
*This photo relates the new trench excavation (to be under the perimeter of the TSF containment wall) to the location of the original impoundment wall (and the revealed overflow containment provision of 1899, at left).*
