1893 Mine Workings Clunes Vicinity

NSX ANNOUNCEMENT – SOUTH CLUNES GOLD ZONES

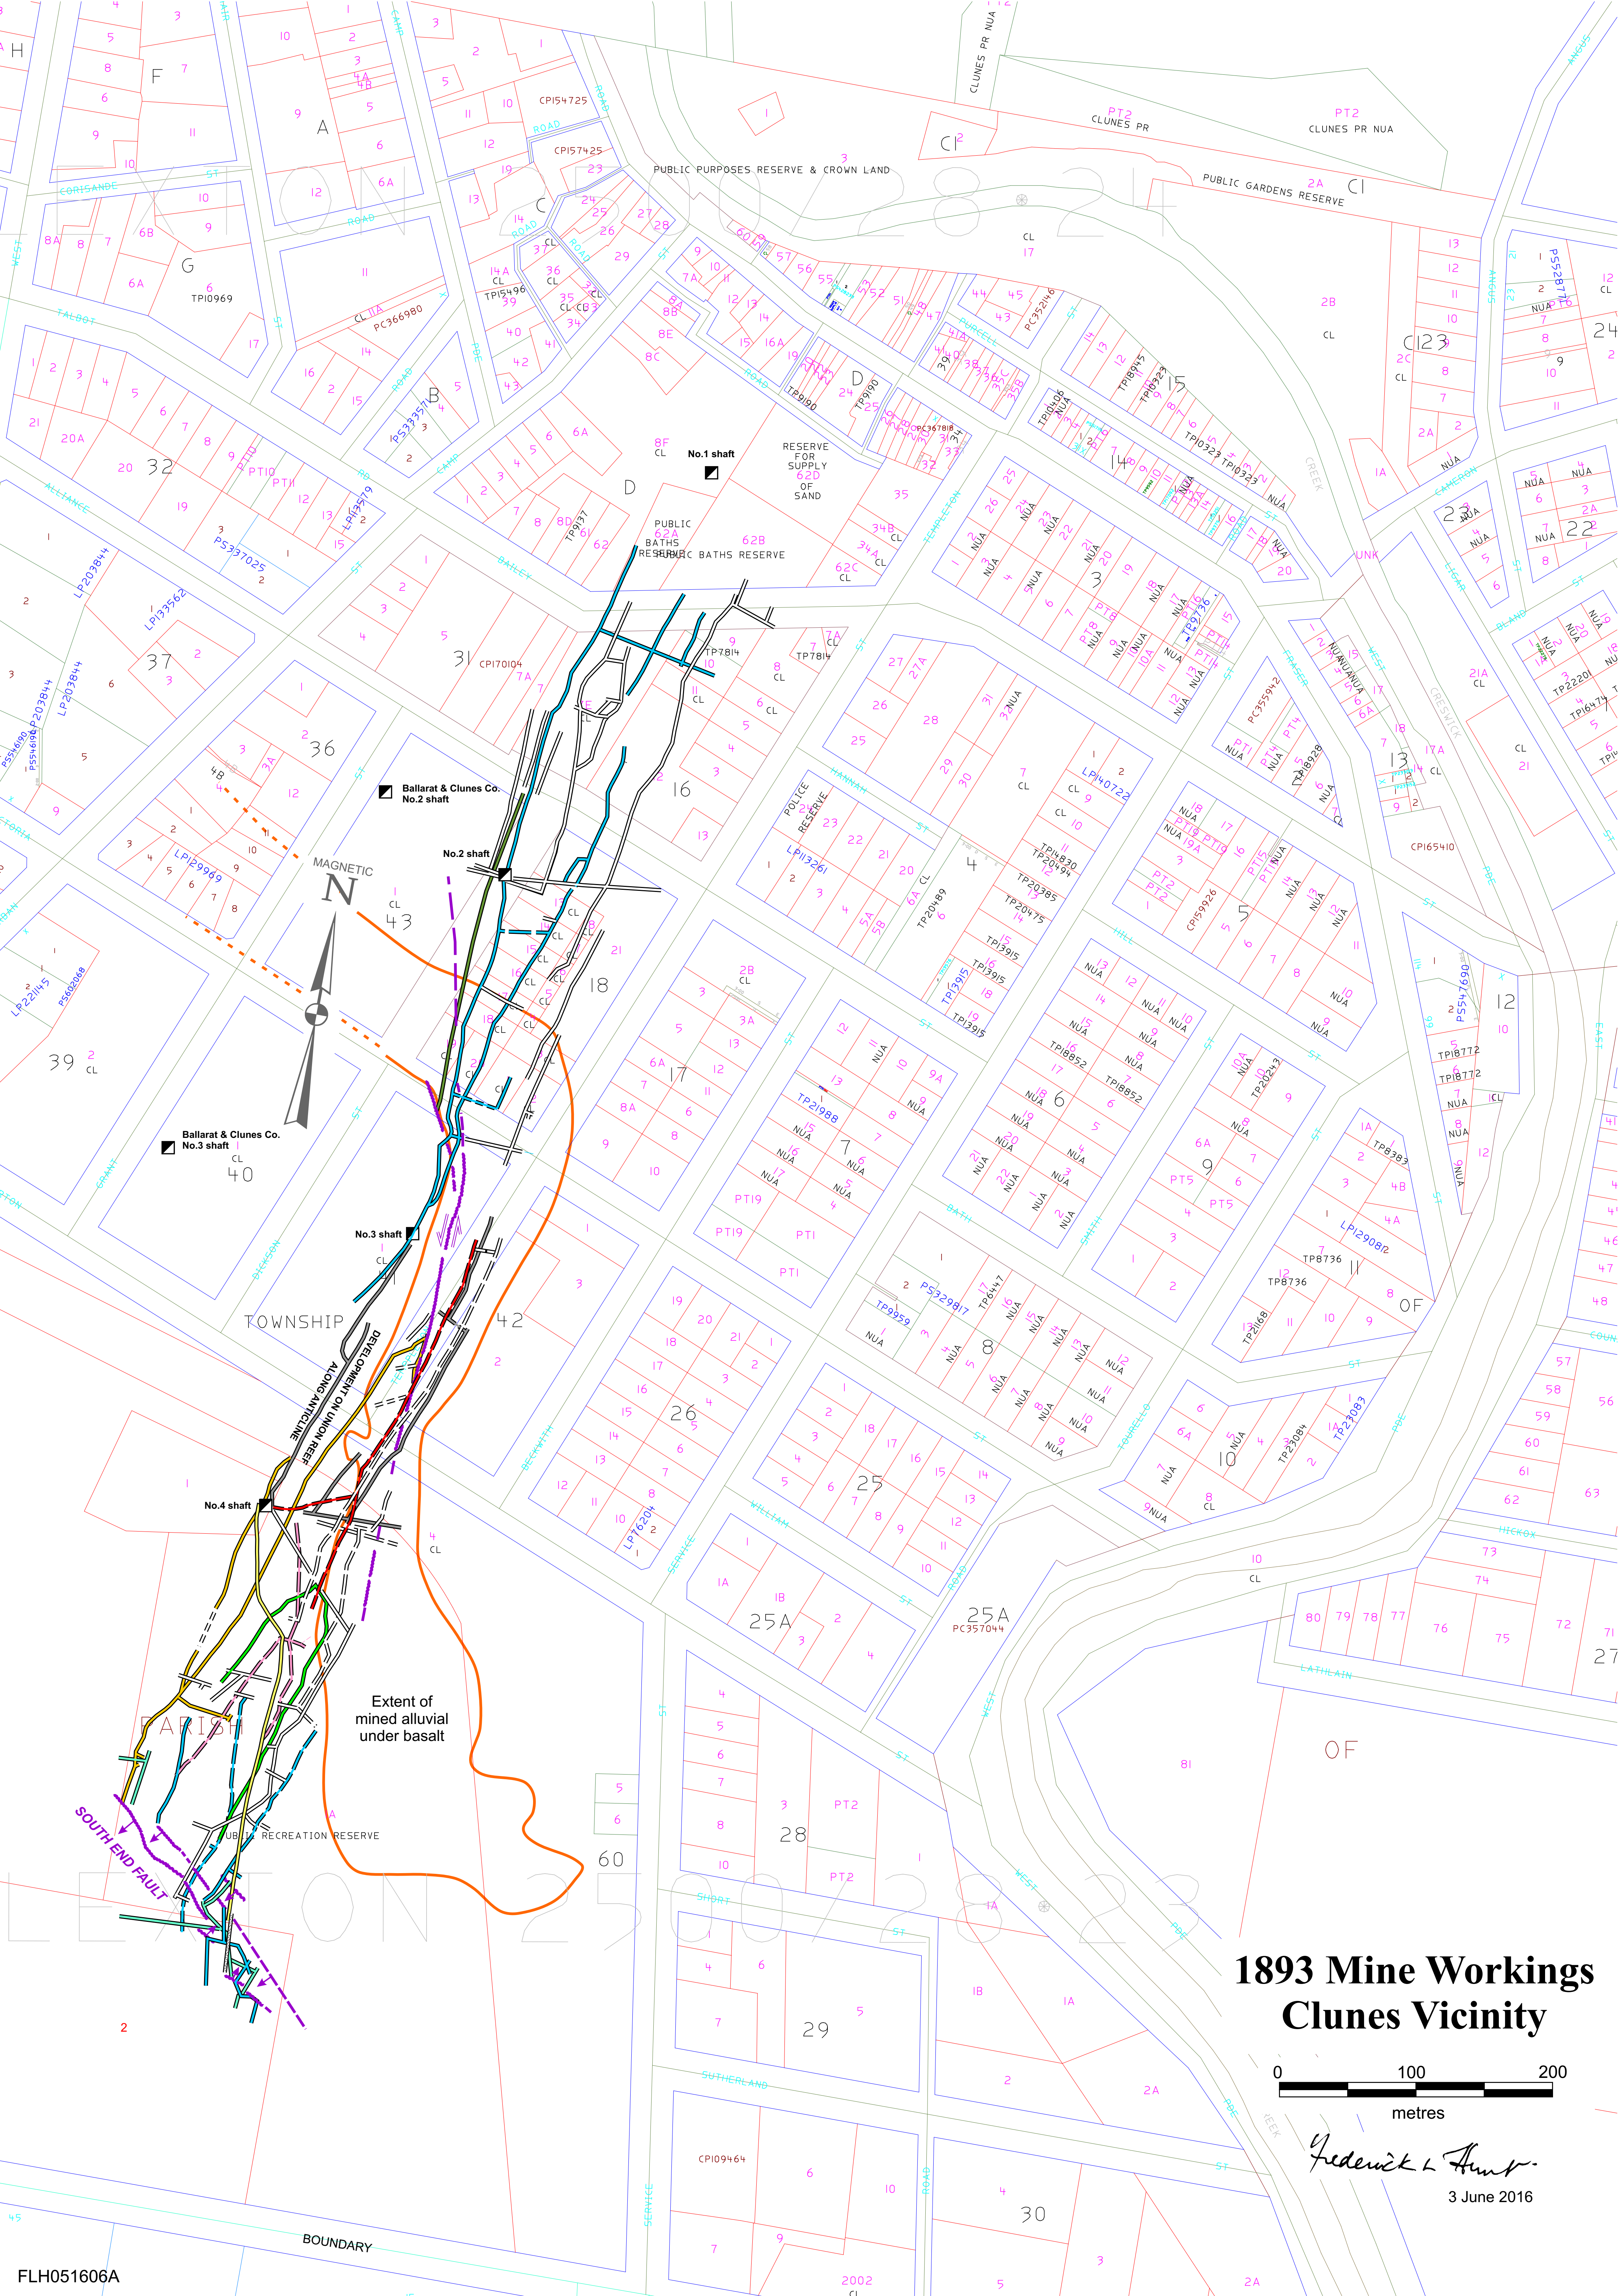
The two drawings published on NSX today are “first disclosures” of the pattern and distribution of quartz veining under the southern part of the Township of Clunes.

These are fact maps, based on plots of underground surveys carried out in 1889 and 1890, or earlier.
Only some workings are shown.

One drawing (titled 1893 Mine Workings) locates the South Clunes No.1 shaft at the north end of the field. In this part there is no lava cover. The workings grew to the south by progressive steps – thus from underground exposures in shaft No.1, the miners knew where to locate shaft No.2, then No.3, and eventually the shaft which later became shaft No.4 on these diagrams.

The lava cover extends to completely hide all the workings shown on these drawings. Gold discovery at Clunes opened Victoria's goldfields to the world, on 29 June 1851. It took 20 years of under-lava investigations before anyone knew where to position shaft No.4 as on these diagrams. The workings extending south from shaft No.4 were brought to a stop (going south) by the ***south end fault*** where marked on both published drawings.

1. The Clunes goldfield, which so far has produced 1.3 moz gold, is frequently given a fixed dimension as to its length. These diagrams show there is absolutely no evidence to presume the goldfields ceases at this ***south end fault***.

4. The entire vein structure extending 1000 metres north of the south end fault is variably auriferous. Crushing of mined quartz from just this southern part of the field has produced a recorded 223,000 oz gold. There is no evidence (from verifiable data in archives) that these veins cease where the workings cease.

5. This gold-mineralised block of ground south of shaft No.1 with a width of about 90 to 100 metres, begins about 50 to 80 metres below the present land surface, and is still present 280 metres down. It is not reasonable to consider this part of Clunes Goldfield has no depth extent, or southern continuation.

These two drawings use selected lines to explain the direct plan location of veining, in relation to overlying Crown land, private land and roads. They therefore convey commercial information of immediate relevance to tenure, and deliberations about who owns what gold rights right now, in this area.

Also included on one diagram is a significant north-trending fault (coloured purple) first recognized by the late A. Edwards, PhD. (Preliminary Review, September 2000) which more recent data suggests may well be one consequence of severe deformation near the close of the mineralization process.
