## GENERAL ANNOUNCEMENT – NSX

A formal Work Plan was lodged with the Department of Primary Industries (DPI) on 30 January 2009, seeking approvals for new work at the Glenfine Project (MIN 5492).

MIN 5492 - Glenfine

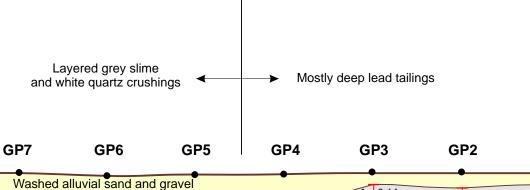
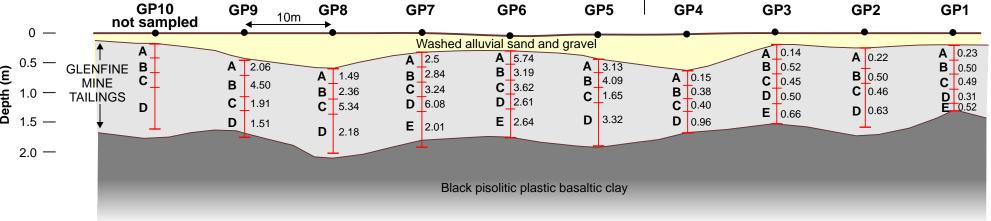
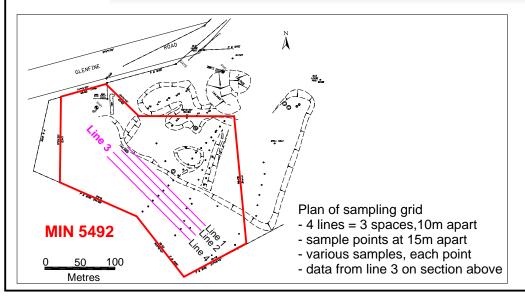
Figure 5

Additional analyses for elements As, Cd, Pb, Zn as a safeguard, to identify the presence of notifiable elements (if any) already existing in waste tailings.

Tailings Sampling Cross Section LINE 3 OF GRID

No correction for slight height variation along section Samples taken to Onsite Labs Bendigo 19-12-2008 For Resource results see related Figure 5.
