GENERAL ANNOUNCEMENT

INTERIM REPORT TO MEMBERS OF MOUNT ROMMEL MINING LTD.

Glenfine Plant

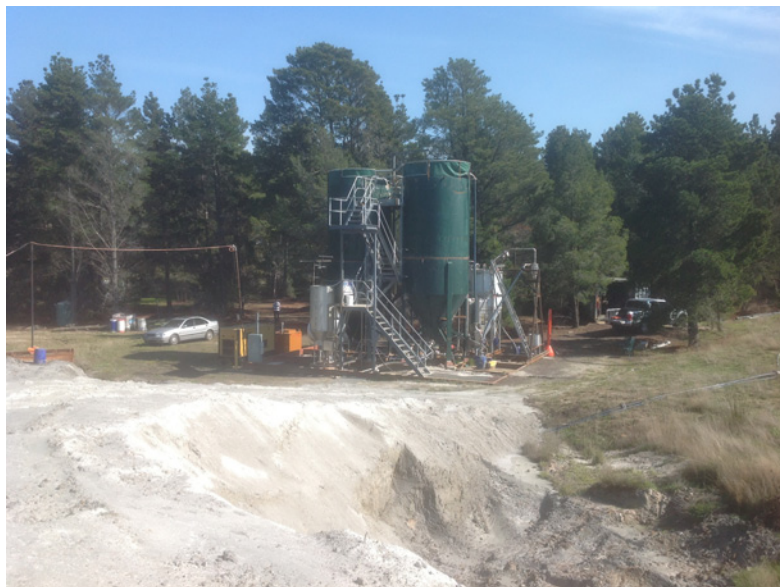
At this site, the state of plant readiness is as shown by the two photographs. The photo below is taken from the near stockpile of tailings awaiting processing. This photo looks to the west, with a person walking on the entry track to left of plant. The main green pachuca tanks are positioned to the front of the two secondary circuit tanks. The top of the feed bin is just visible above sand at far left of photo.

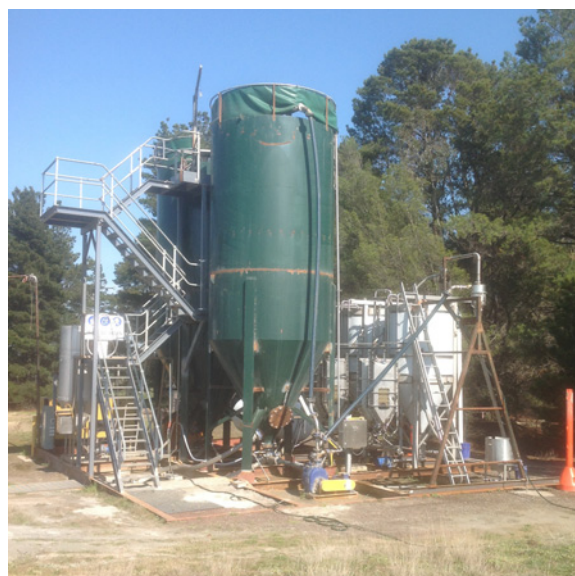
The photo below looks to the south, from a location on the wall of the Tailings Storage Facility.
